HISTORIC STRUCTURE REPORT

VOLUME II

COIT TOWER SAN FRANCISCO, CALIFORNIA

April 1989

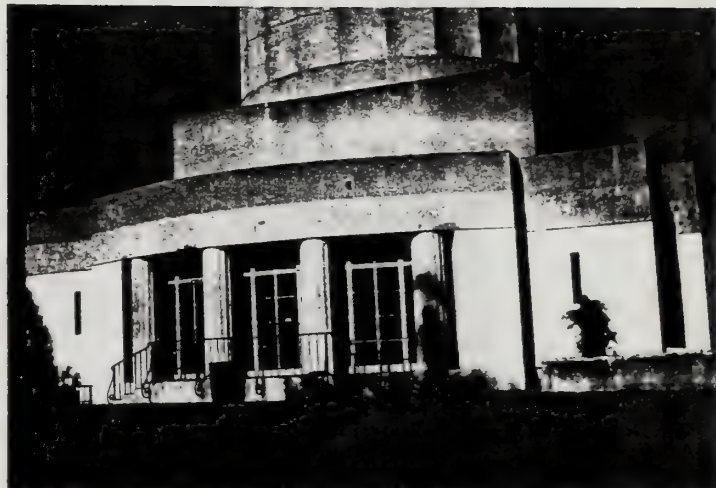
1. South Base Elevation

At the tower base level, both the exterior first floor walls and the second floor walls adjacent to the tower were investigated. Photo 1, of the south wall, shows the typical condition. In addition to the walls forming the base, two wing walls with doorways projecting from the north entry wall were inspected. The west wall is shown in Photo 2. Two major types of deterioration are evident. These are cracking of concrete and surface spalling or separation of concrete due to corrosion of reinforcement. Each problem takes several different forms and may have several different causes. Each requires correction to prevent further deterioration. In addition, the concrete finish coat is chipped and badly discolored in many locations.

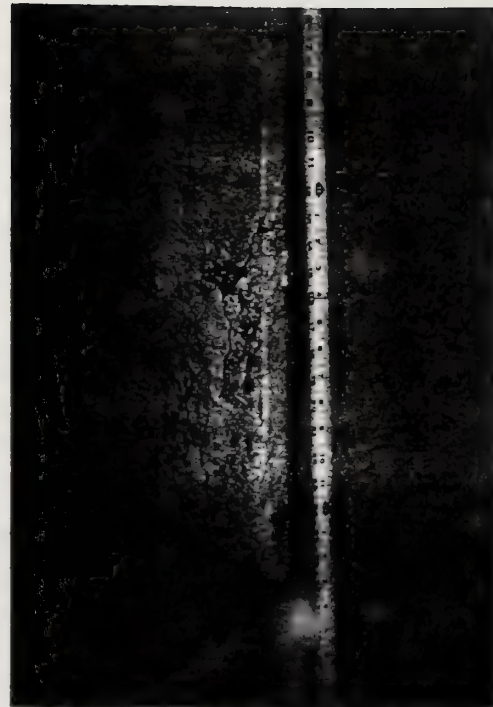
Cracks occur at the base walls at a variety of locations. Most are caused by exposure to severe weather and inadequate concrete cover over reinforcement. Photo 3 shows vertical corner cracks occurring at the base of a wall. As seen in Photo 4, additional cracks occur around

3. Cracks at Wall Base

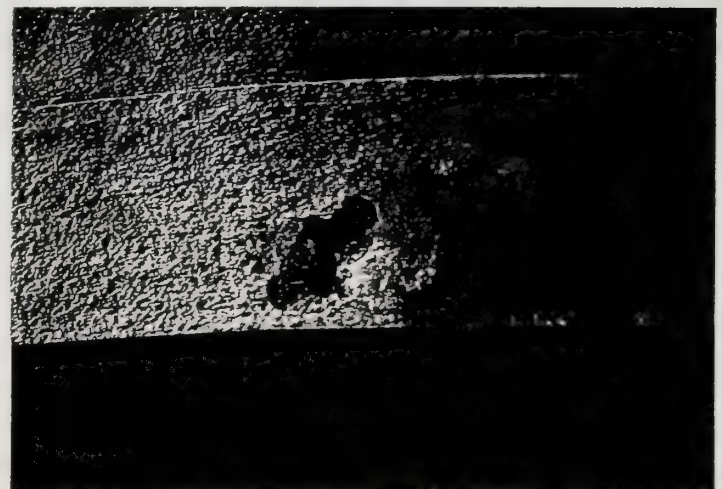
Spalling is a serious problem at the base level. Photo 5 shows a typical large spall on the fascia beam. The corroded reinforcement and associated delamination are fully exposed. In many cases, the spalls have already been patched, as shown in the left of Photo 5. These patches vary in size, color and texture, creating an unsightly appearance. More importantly, the patches have questionable durability due to the use of higher strength, dissimilar concrete patch material with different expansion characteristics. This problem, along with incomplete patching techniques may be concealing ongoing hidden deterioration. Thus, to provide consistent and adequate protection against further spalling, it is recommended that all previous patches be removed and all spalls patched according to the repair procedures outlined in this report. In addition to the large spalls with exposed corroding reinforcement, there are many small (4 inch maximum diameter) spalls. These appear to be caused by form tie wires, left in place, which have corroded and popped off the surrounding concrete. These small spalls, though presenting no serious

5. Spall at Fascia Beam

structural problem, should be repaired to prevent future deterioration and to preserve the overall appearance and longterm integrity of the structure.

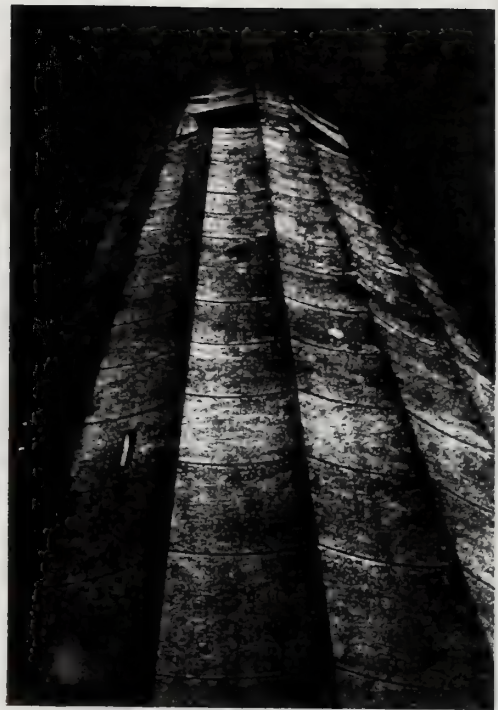
The tower walls, although not surveyed in detail at this time, were photographed and observed from the roof level and base level. From these observations, general conclusions about the extent of the deterioration can be drawn with a limited degree of accuracy. Photo 8 shows a sample of the apparent overall condition of the tower. With the exception of some chipping of the covering material and eroding of the fluted edges, the most prevalent visual problem is the occurrence of small spalls at form ties. These can be seen in Photo 9. From the ground, a large spall was observed at the top rim of the tower, indicating more extensive damage is present at certain areas. Our assumptions will be verified and any further tower deterioration will be specifically identified at a later date, when scaffolding is available to provide access to the tower surface.

8. Overall View of Tower

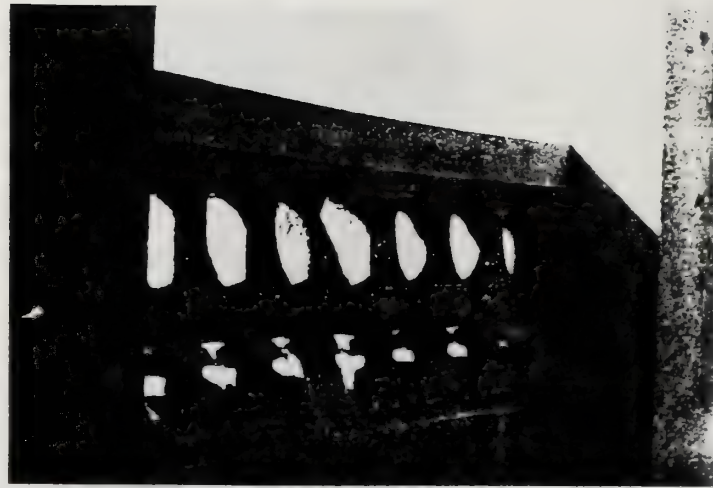
The most unique and potentially dangerous problem at the Belvedere level is the severely scaled and cracked balustrade which forms the exterior railing between the arches. Photo 10 shows the typical balustrade condition. These balustrades have experienced extreme erosion and disintegration and, as such, are a hazard to people and property below. The entire balustrade should be removed and replaced.

10. Balustrade

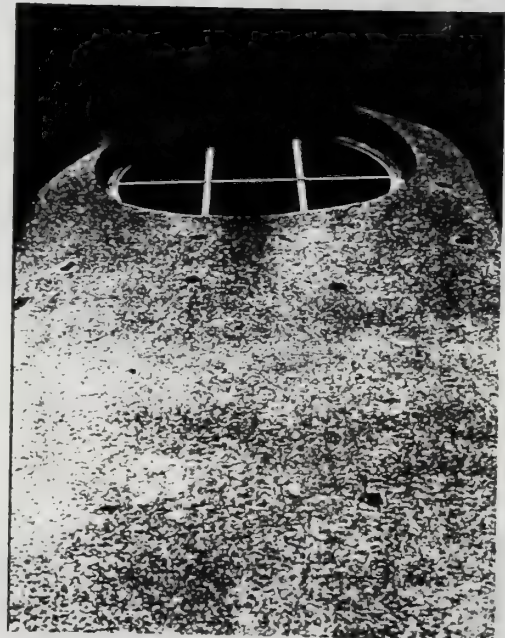
13. Form Tie Spalls on Core Wall

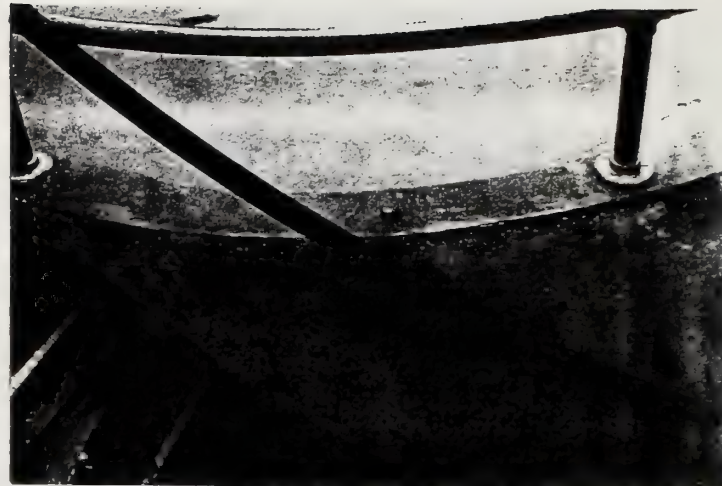
14. Spalls and Cracks at Stairs

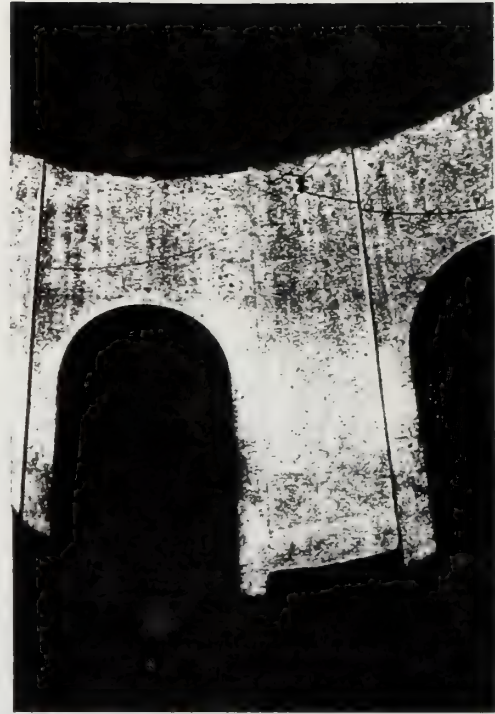
In addition to these two problems, patterned form tie spalls were observed on the lower arches and the upper arches which form a ring at the top of the tower. Photo 17 shows a typical section of upper arches. The extent of these patterned spalls is similar to that found on the Belvedere level core walls.

17. Form Tie Spalls at Upper Arches

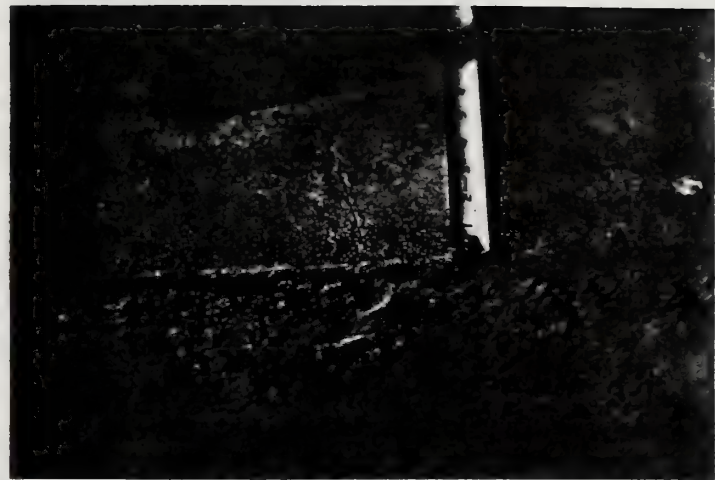
E-c. Minor Crack at Base Level

| Item | Description | Quantity | Sect.-Photo* |
|---|---|---|---|
| 1 | Less than 1/32" wide crack. No repair required. | Typ. Cond. | E-c |

Due to the wide range of crack sizes and severity, the repair process would best be handled by a combination of procedures. A minor repair, involving injection of a sealing material is recommended for narrow cracks (less than 1/32 inch wide) or cracks located in areas of construction joints (Photo E-e) or for those due to shrinkage effects. Some of these minor cracks may remain unrepaired, depending on their size and location. A major repair, requiring that the crack be opened up, reinforcement inspected for corrosion and then patched (Photo E-g), would be required at wide cracks or where there is a possibility of corrosion occurring below. Most of the cracks on the surrounding entry walls, planters, and stairs may remain unrepaired since they appear narrow and shallow and affect non-structural concrete elements. However, prominent, deep cracks should be injected, or in severe cases, patched, to preserve the quality of the concrete. Recently patched cracks at the lower roof walls may remain without further repair.

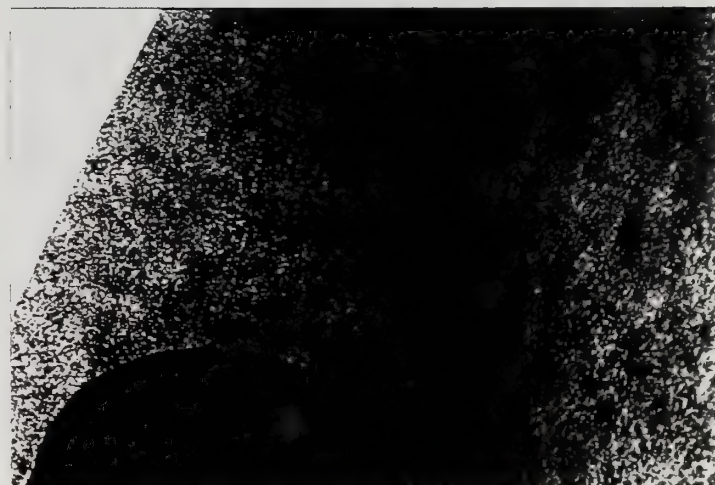
E-e. Minor Crack at Belvedere Level

| Item | Description | Quantity | Sect-Photo* |
|---|--|---|---|
| 6 | Horizontal crack above arches and inside wall, 10 Ft. above floor | 168 Ft. | E-e |

Another repeated location of cracking was adjacent to window and grate openings. (Photo E-h). This typically is an area of high stress and some cracking is not uncommon. The final location noted for repeated cracking was at construction joints. At the base walls, horizontal cracks were noted near the ground along a line in the wall face, probably indicating a joint between the foundation and wall above. At the Belvedere level, horizontal cracks were observed along the perimeter of the wall and colonnade (Photo E-e). From the inside stairwell, a construction joint and fine crack were observed in the same location.

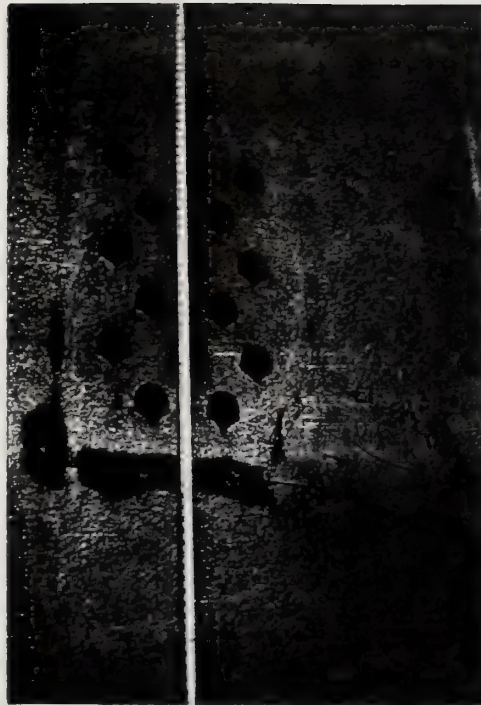
E-h. Cracking at Grate

| BASE WALL DETERIORATION SURVEY TABLE | | | |
|---|---|---|---|
| 12 | Cracking and water leakage at wall grate. | 1 Ea. | E-h |

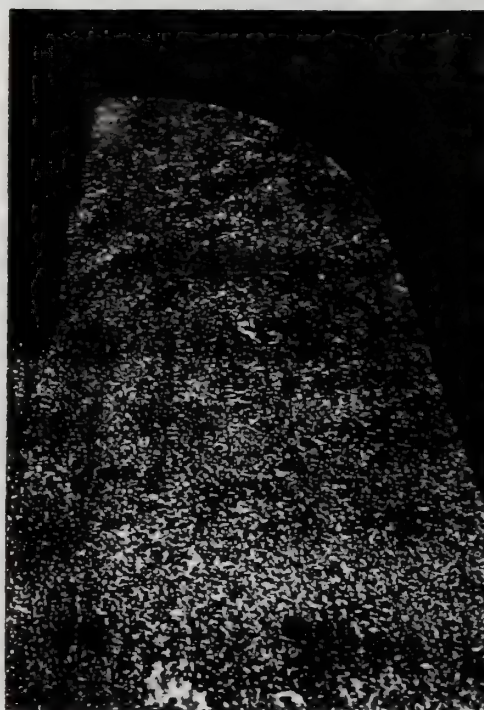
F-b. Patterned Form Tie Spalls
at Belvedere Level

| Item | Description | Quantity | Sect-Photo* |
|---|--|---|---|
| 2 | 1" to 4" diameter form tie spall pattern on inside wall, patched or unpatched. | Approx. 375 Ea. | F-b |

There is often a definite pattern to the location of these spalls, as can be noted on the elevations presented in this report (Photo F-b). The pattern of the spalls observed at the Belvedere and Root levels, supports the theory that they are form ties. However, at the Base level there is a certain randomness to their location. This may be because some ties have not yet been affected. The tie ends

Though the pitting of the walls is unsightly, it is generally not a structural problem and probably will not propagate into a more severe condition. If the corroded tie is close to a larger bar, however, corrosion may be initiated in that bar, too. Therefore, to enhance the overall condition of the building, and prevent further deterioration, each small spall should be repaired.

It is recommended that the loose, disintegrated concrete surrounding the corroded form tie or reinforcement be hammered out, exposing all the corroded steel. The steel should then be cut off, at least half an inch beyond the corrosion. The edge of the concrete area should be cut to prevent feathering and to provide a keyed patch. Existing patches should be removed and replaced in a similar way. Slight bumps and flaky cracks in the surface should be tapped with a hammer to determine if a corrosion or delamination has begun below the surface. If the concrete flakes off, the area should be patched as a typical small spall. A less rigorous repair would be

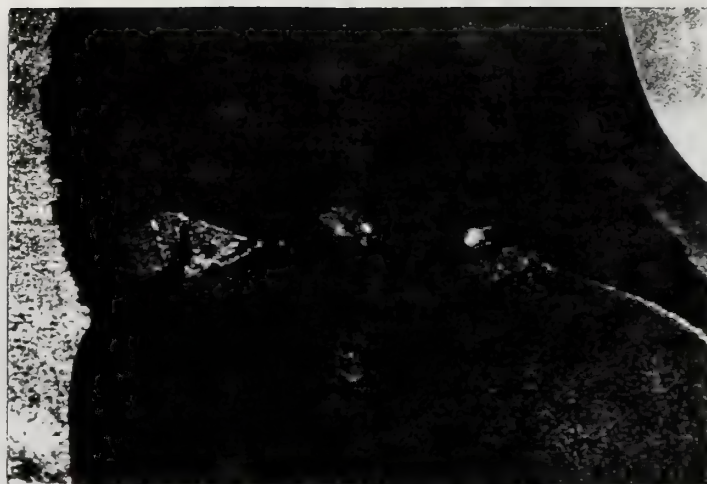
G-a. Spalls with Exposed Reinforcement

| Item | Description | Quantity | Sect-Photo* |
|---|--|---|---|
| 3 | 4" to 12" diameter spall, corroded reinforcement exposed. | 10 Ea. | G-a |

The repair procedure for spalls needs to be adjustable and adaptable depending on the scope of the corrosion occurring. Each spall will require some type of patch, and existing patches should be removed and replaced. Figure G-2 shows recommended patch preparation. A good concrete patch requires the removal of all loose, disintegrated concrete including concrete that shows evidence of active or potential spalling. Since delaminated areas or spalls may extend beyond the area of the exposed bar, concrete in the surrounding areas should also be removed. If more than 1/2 of the circumference of the bar is exposed before or during the removal process, the bar should be completely exposed with sufficient clearance under the bar to insure encasement and bond with the new

patch. All steel should be cleaned, and loose, scaly rust must be removed. Areas to receive a concrete patch should be cut to prevent feathering and to provide a keyed patch. Reinforcing bars located in areas too near the surface to receive a concrete patch should be removed or painted. Some spalled areas, such as column corners and beam soffits will require special concrete forms to complete the repair properly. The patching concrete material may be modified with latex or polymer to improve its bonding and water resistance and to give it properties similar to the original concrete.

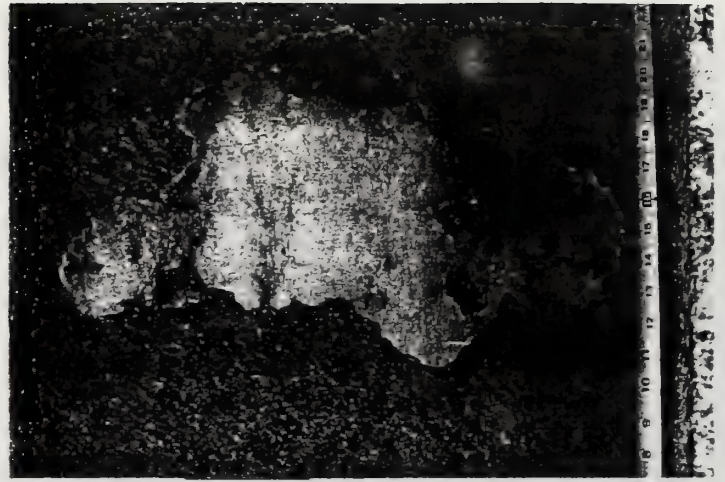
A prevalent condition on exposed concrete surfaces is chipping and peeling of the existing concrete surface coating. The coating appears to be a stucco or sand based cement plaster, applied very thinly over a majority of the tower surfaces. In some areas the coating has been painted and in others, left unpainted. The major cause of the deterioration of the coating is the harsh environment surrounding the tower. The damp and cold atmosphere has penetrated the coating and may have caused the concrete beneath to suffer carbonic acid attack as evidenced by the white deposits on the surface.

The ineffectiveness of this coating to protect the concrete from moisture penetration results in greater deterioration of the exposed structural concrete.

H-a. Surface Coating Delamination

To preserve, as much as possible, the integrity of the structural concrete, the existing coating should be removed and replaced with a more effective, durable type of coating. Before any repairs are made, the existing coating should be removed by steel brush, sandblasting, or

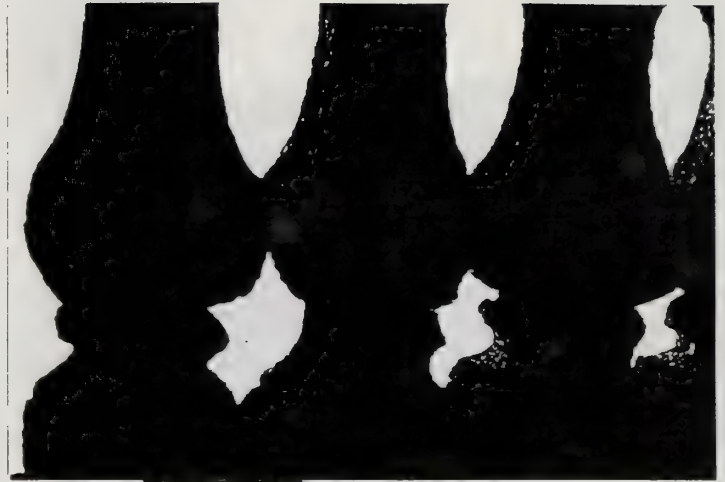
The scaling and crumbling of the concrete balustrade at the Belvedere level is a unique problem. The balustrade encircles the Belvedere level and is a prominent architectural feature. Once again, however, severe weather conditions have caused damage ranging from minor scaling and cracking, to disintegration and separation of concrete due to corrosion. In some places, the concrete easily breaks off, creating a hazardous situation to people and property below.

J-a. Overall View of Balustrade

It appears, from the drawings and field inspection, that the balusters are precast items attached to the cast-in-place handrail with dowels. The repair may be accomplished by replacing all attached balusters and rail with a new, identically precast unit. This unit could consist of individual balusters, assembled in place with a cast handrail, or a complete unit, assembled on the ground and lifted into place. This unit would then be protected with the same coating as the rest of the structure.

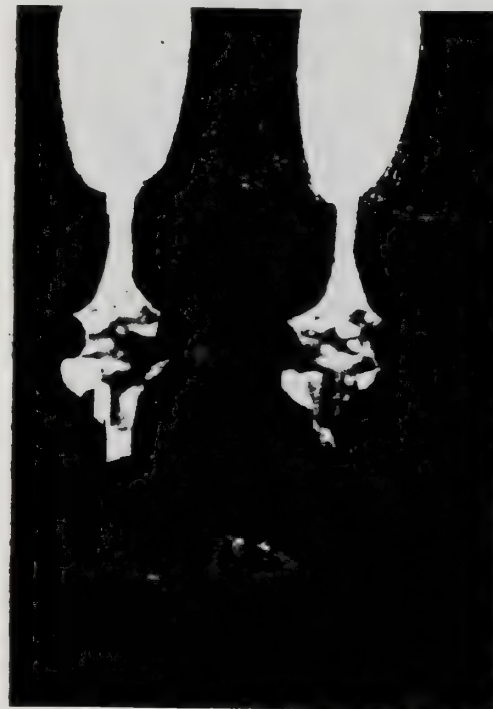
J-b. Spall at Baluster

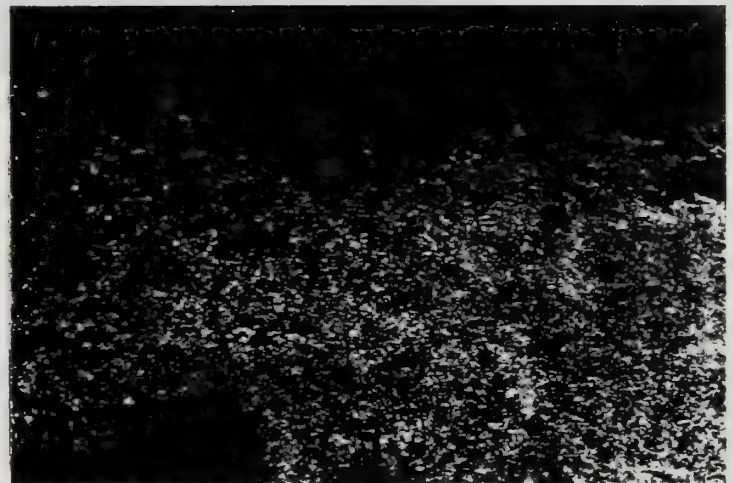
Above each archway on the Roof level, there is a depressed roof area, approximately four feet by seven feet. The ceiling beneath this area is peeling and flaking indicating that water may be penetrating the roof slab. Fine cracks were observed on the bottom surface of the roof slab. In addition, the previous roofing material is almost entirely disintegrated. At the inside parapet of each roof area, a scupper was provided to drain the roof water from the roof to the deck below. However, the delamination of the ceiling below indicates that these scuppers are not functioning adequately. To prevent scaling of the new surface coating, this area should be provided with new roofing and a positive drain.

K-b. Upper Roof Slab Crack

It is recommended that a sloping topping of concrete be applied, if necessary, to ensure that water will drain from the roof to the scupper. A waterproof membrane should be applied over this topping to protect the concrete.

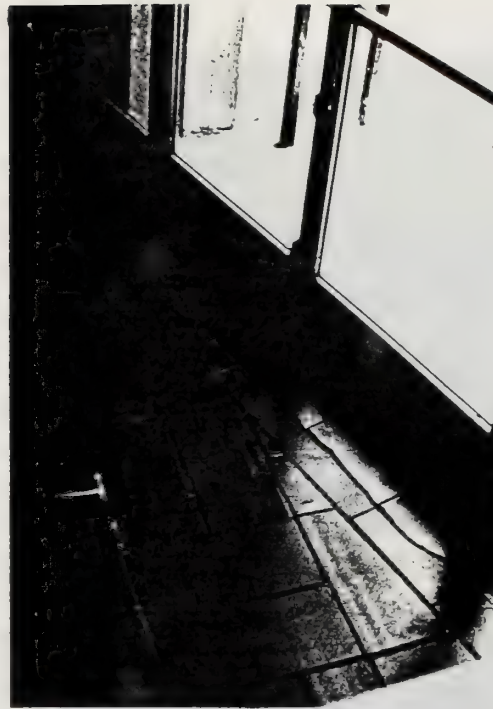
At the West wall of the lobby, there is a wide crack along the edge of the tile floor near the windows (Photo L-a). A detail of the connection of the floor slab to the perimeter footing at this location was found in the original structural drawings, Section D-D, Sheet 53A. Figure L-1 is a reproduction of the slab joint detail. Either settlement of the soil or rotation of the footing may have caused a void to form under the slab. The slab settling into this void created stresses which cracked it and the floor tile.

L-a. Lobby Floor Crack

It may be necessary to investigate the soil below the slab to determine if additional settlement may occur. This study would involve removing the tile and base material adjacent to the crack, coring the slab and performing a soil consolidation test in place. The soil could then be stabilized and compacted as required. The slab could then be replaced or repaired as required. The tile base material would be replaced and built up, and the original, or matching tiles placed. A less rigorous repair would be to simply replace the tile, assuming that the slab will not settle

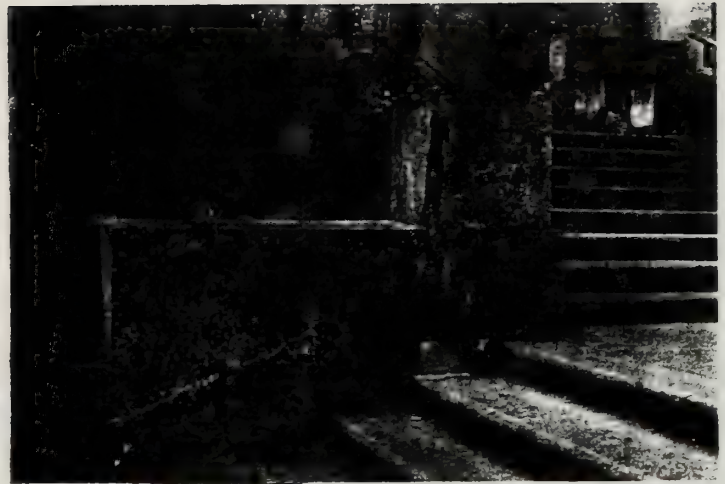
Another soils problem occurs at the lower east retaining wall near the entry stairs. The stump of a large tree is hidden behind the wall, indicating a powerful root system once pushed the retaining wall and caused the severe cracking and rotation evident in Photo M-a.

M-a. Front Retaining Wall

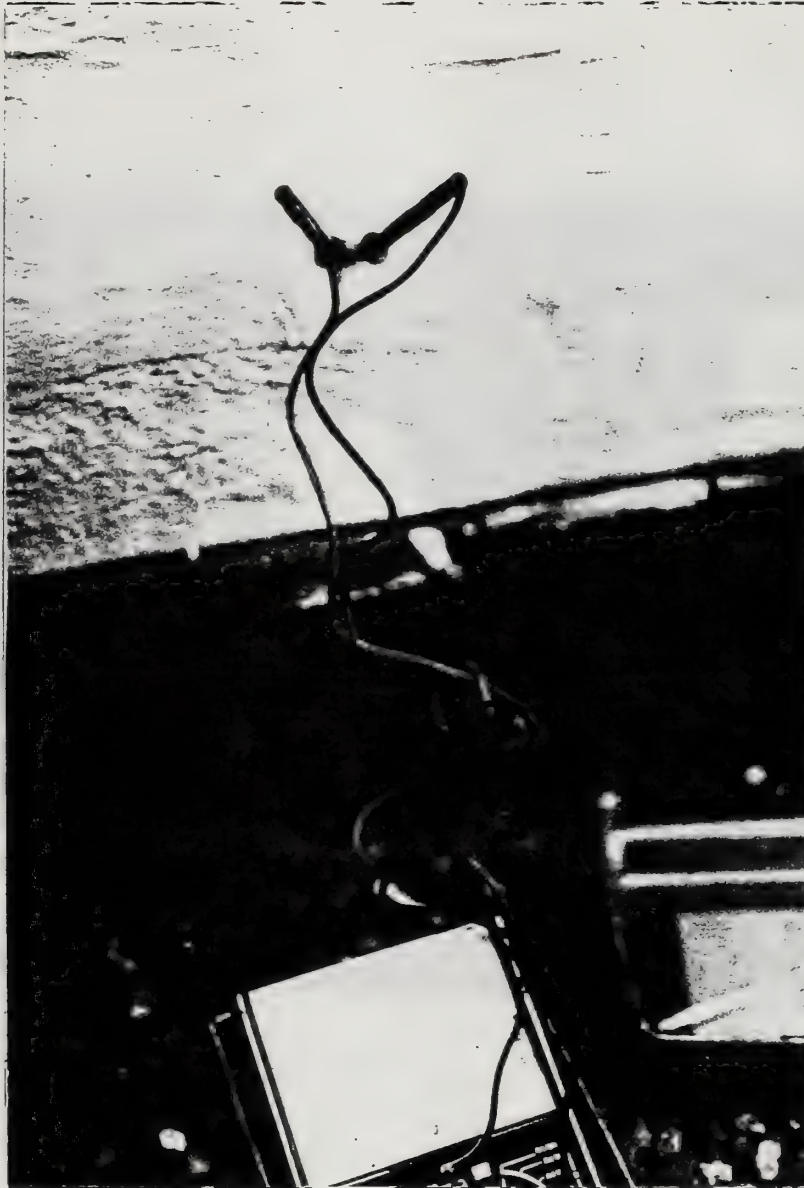
PHOTO A

At one particular "bulged" area of the concrete plaster on the west parapet wall, moisture was verified in the elastomeric coating (Photo A) beneath the surface skin of the coating, indicating moisture penetration of the concrete plaster surfacing. For purposes of comparison, another sample of the elastomeric coating was checked for moisture content by electrical continuity (Photo B) and no continuity was observed, indicating a dry sample.

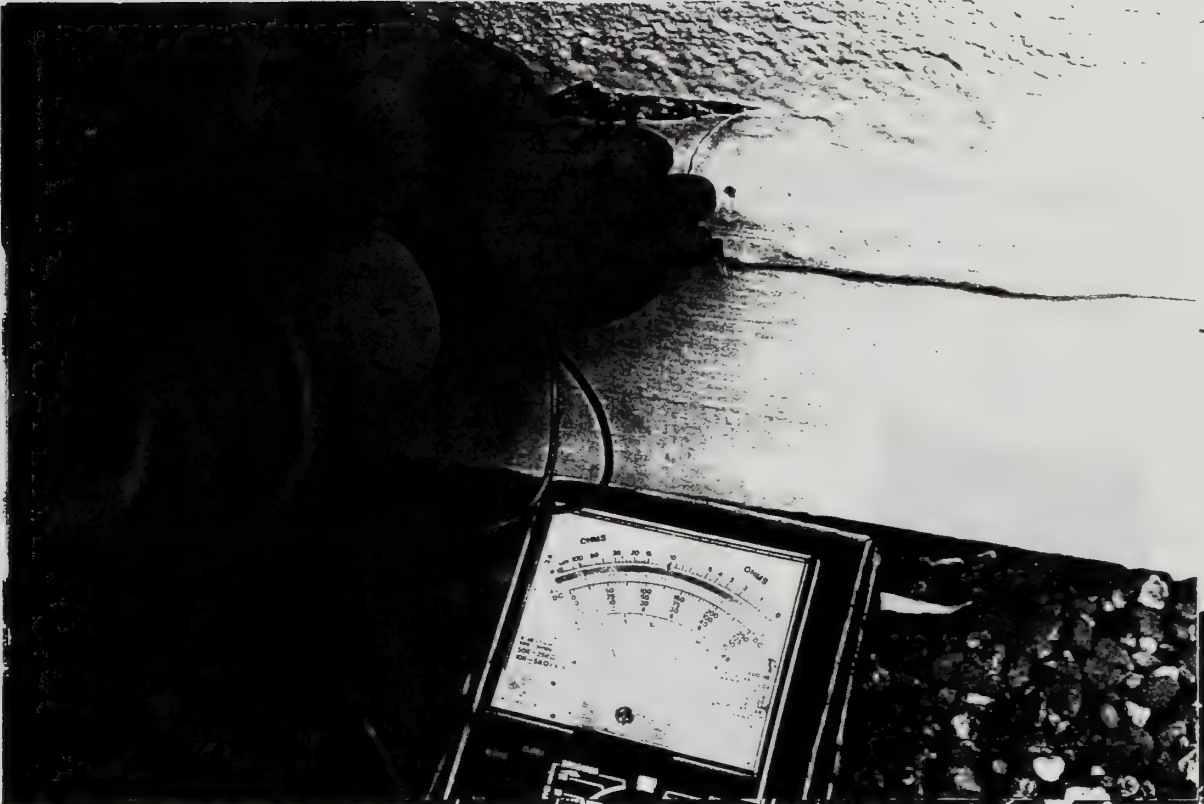
PHOTO C

Additional areas were observed two days after a severe rain and continuity tested for moisture. Our findings were observed by taking comparative electrical continuity readings above the counterflashings (Photo C) and then beneath the counterflashings behind the base flashing (Photo D) of the roof system. In all cases, continuity readings were observed at both test locations, indicating water migration into the concrete plaster surfaces, behind the counterflashing system and behind the base flashing of the roof system.

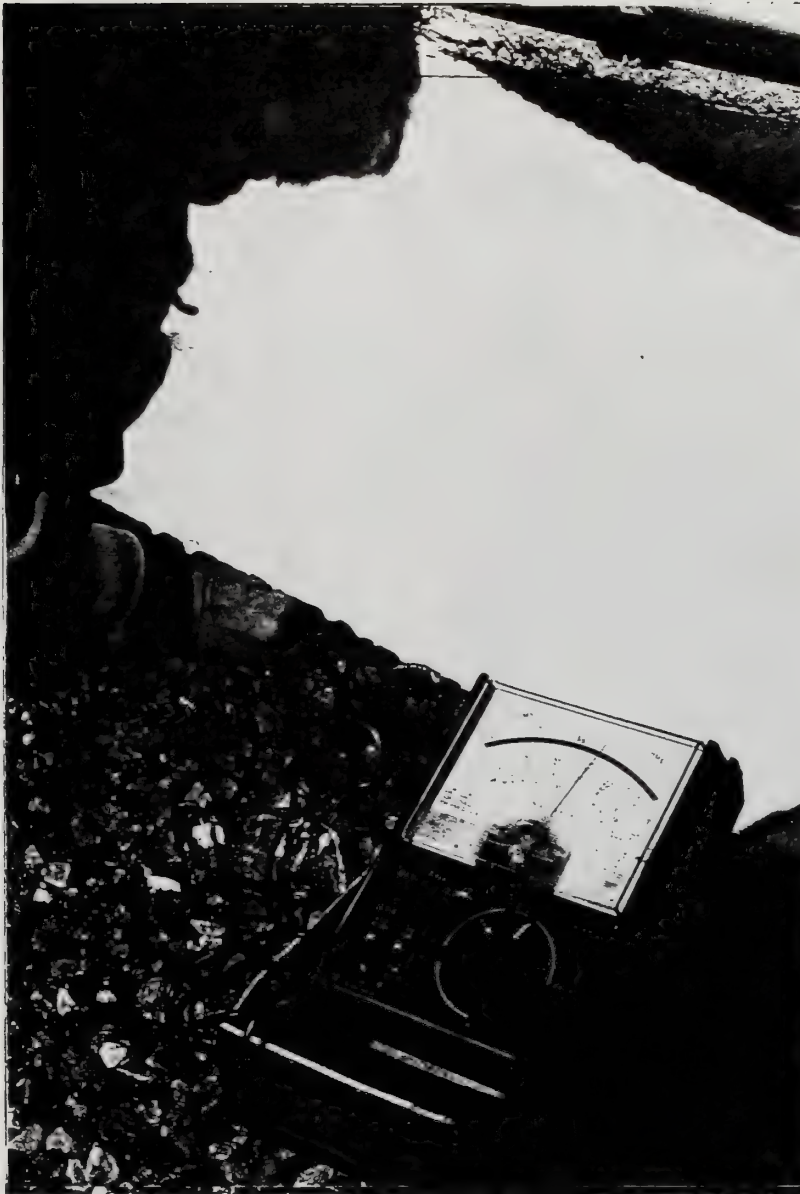
PHOTO H
Same area as Photo G but behind
roof flashing.

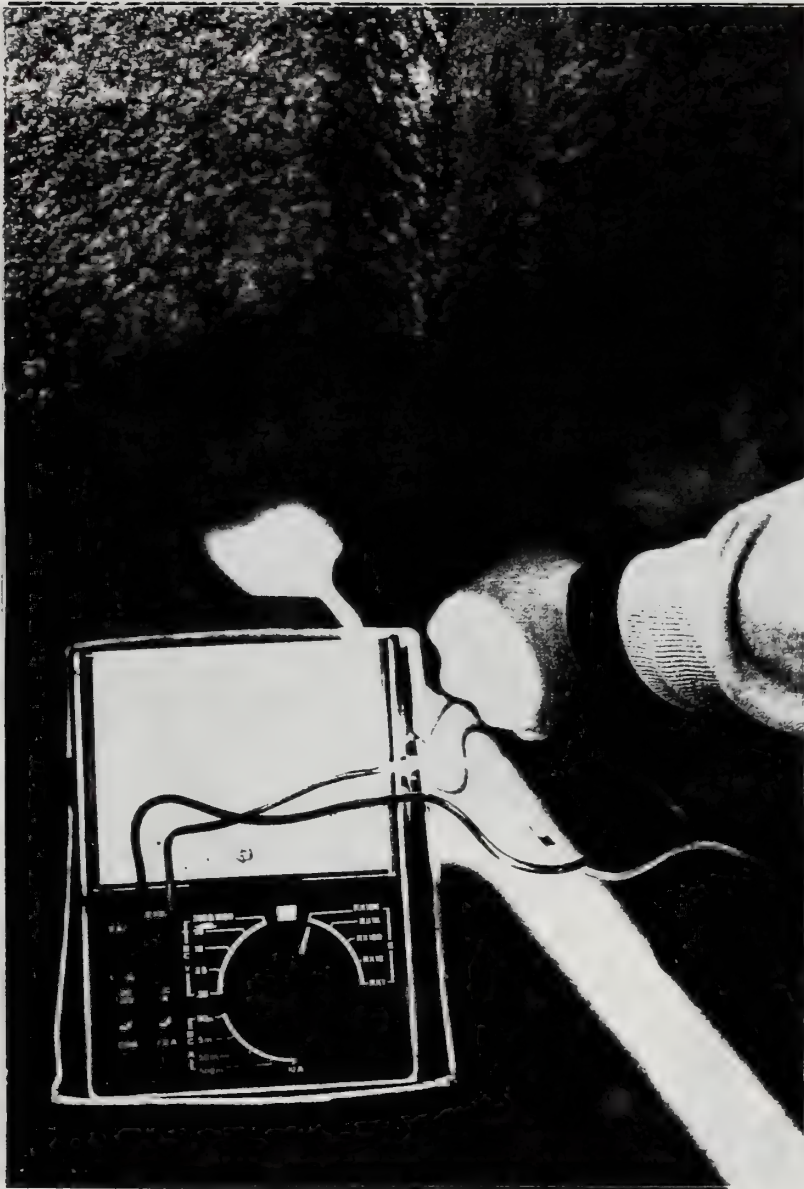
PHOTO N

There is cracking of the membrane at various base flashing locations with indication of moisture behind the membrane system (Photo N). The top edge termination of the base (Photo P) flashing is showing adhesive release in a few isolated locations. A continuity test of one of these areas two days after a rain gave a positive low reading, indicating moisture penetration behind the membrane system.

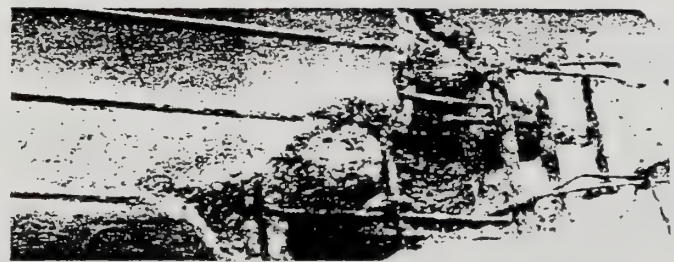
Fig. 13b. Upon removal of the deteriorated surface, a pocket of poorly mixed concrete (mostly sand and gravel) was easily chiseled out. The reinforcing rods were in good condition.

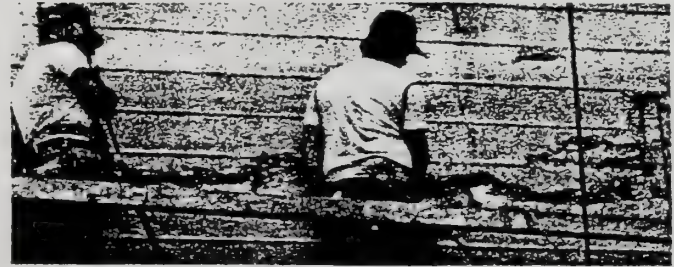
Fig. 13d. Deteriorated or redundant reinforcing bars are removed after evaluation by a structural engineer. An acetylene torch is being used to cut out the bars.

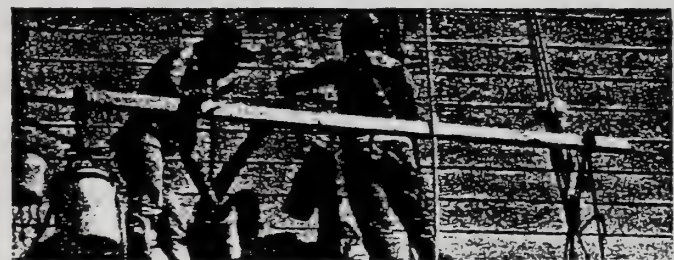
Fig. 13f. Workmen are applying patching concrete and using a trowel to form ridges to match the appearance of the historic concrete ridges that were originally created by the form boards.

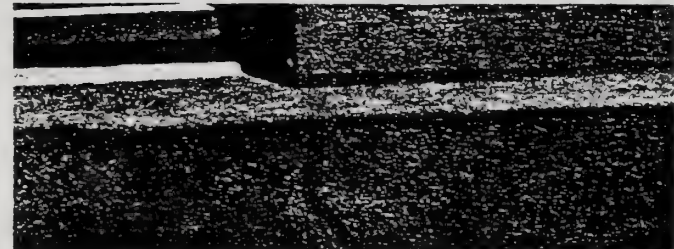
Fig. 13h. This active crack at a window sill and in the foundation wall has been filled with a flexible sealant. This area was subsequently painted with a masonry paint compatible with the sealant.

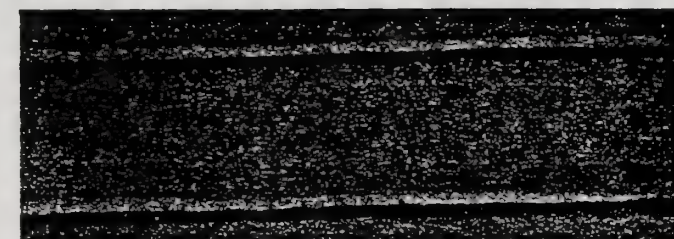
Fig. 13i. Upon completion of all repairs, the building was painted. The finished repair of the deterioration seen in 13a and b is shown in this photograph. The patch matches the texture and detailing of the historic concrete.

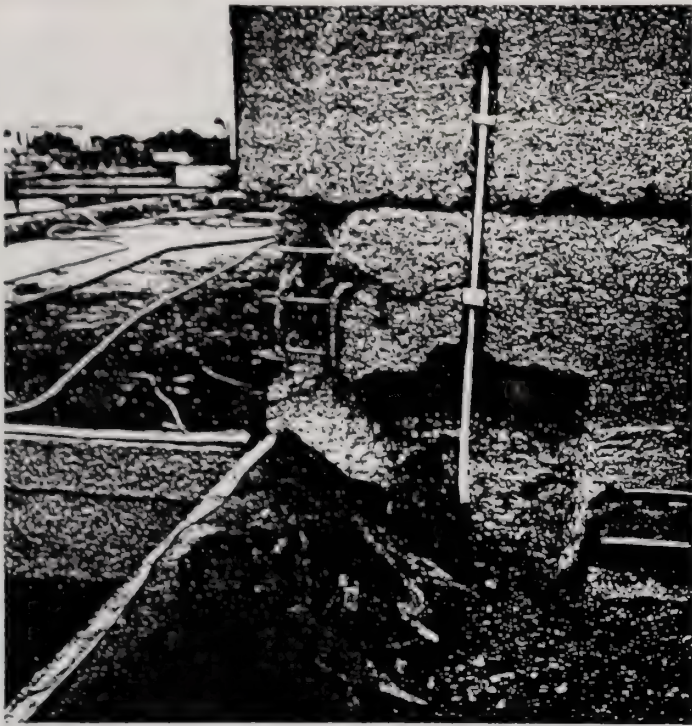
Fig. 14a. Spalled concrete was most noticeable at locations of concentrated rebars. Deteriorated concrete, the 1960s stucco finish, and corrosion were removed by grit-blasting. Photo: Robert Bell.

Fig. 14a-c. Unity Temple, Oak Park, Illinois (1906). Architect Frank Lloyd Wright used cast-in-place concrete with an exposed aggregate finish. However, reinforcing bars placed too close to the surface resulted in corrosion, cracking, and spalling. A superficial repair in the 1960s coated the surface with a concrete mix and Portland cement paint which produced a stucco-like finish and accelerated deterioration. Repair work was undertaken in 1971.

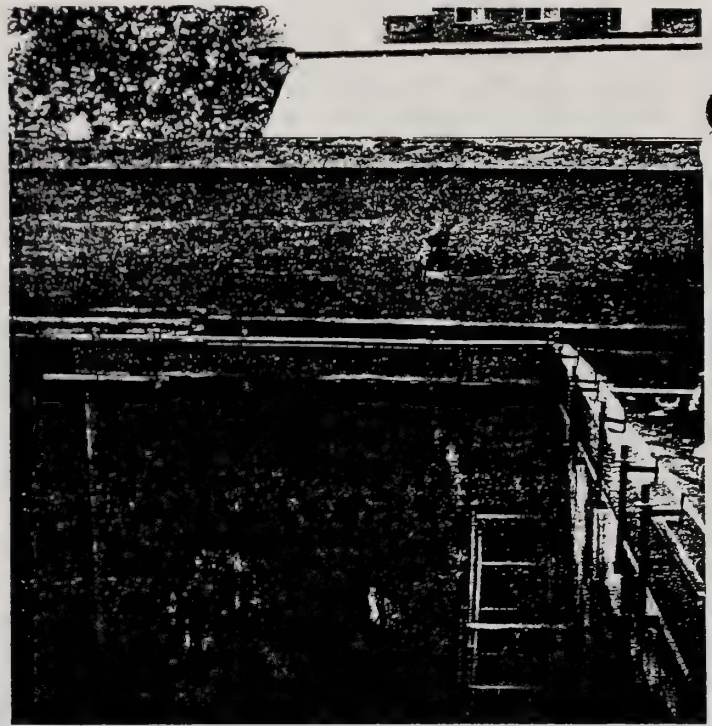
Fig. 14b. Board screeds were attached to the building to recreate the sharp edges of the original detail. Photo: Robert Bell.

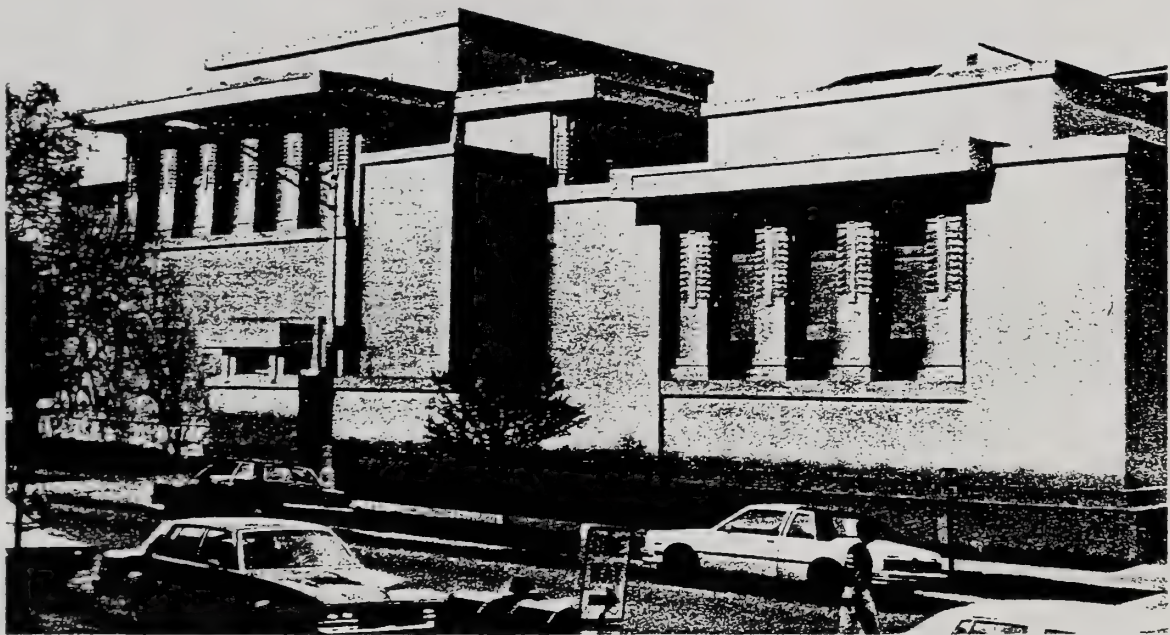
Fig. 14c. Once the repair work was complete, the entire building was sprayed with a concrete mixture consisting of pea-gravel, cement, and sand, which was then hand-

troweled. Finally, the building was lightly grit-blasted to remove the cement paste and reproduce the exposed aggregate finish. Photo: Harry J. Hunderman.

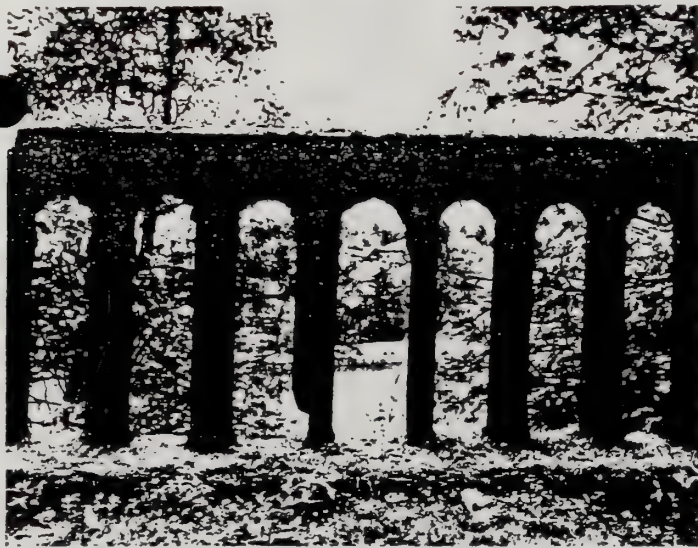
Fig. 15a. The spindle-type railings were deteriorated beyond repair. The concrete was cracked or broken and the center reinforcing rods were exposed and badly rusted.

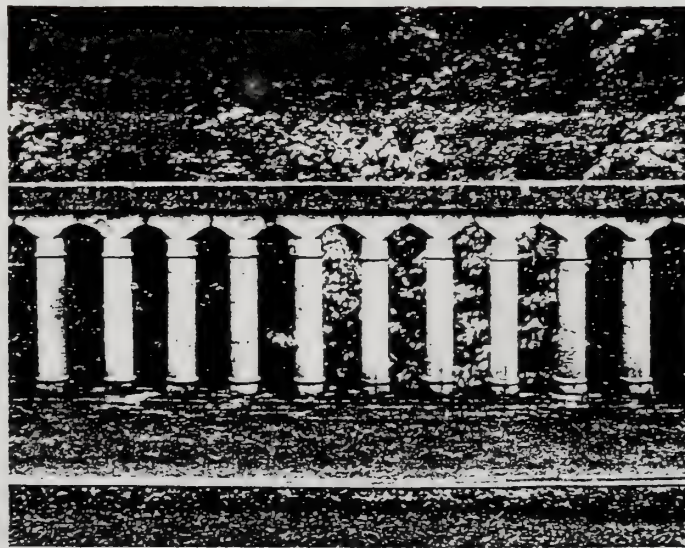
Fig. 15b. Deteriorated spindles were removed. The original 1914 molds were still available and used in casting new concrete spindles, but had they not been available, new molds could have been made to match the originals.

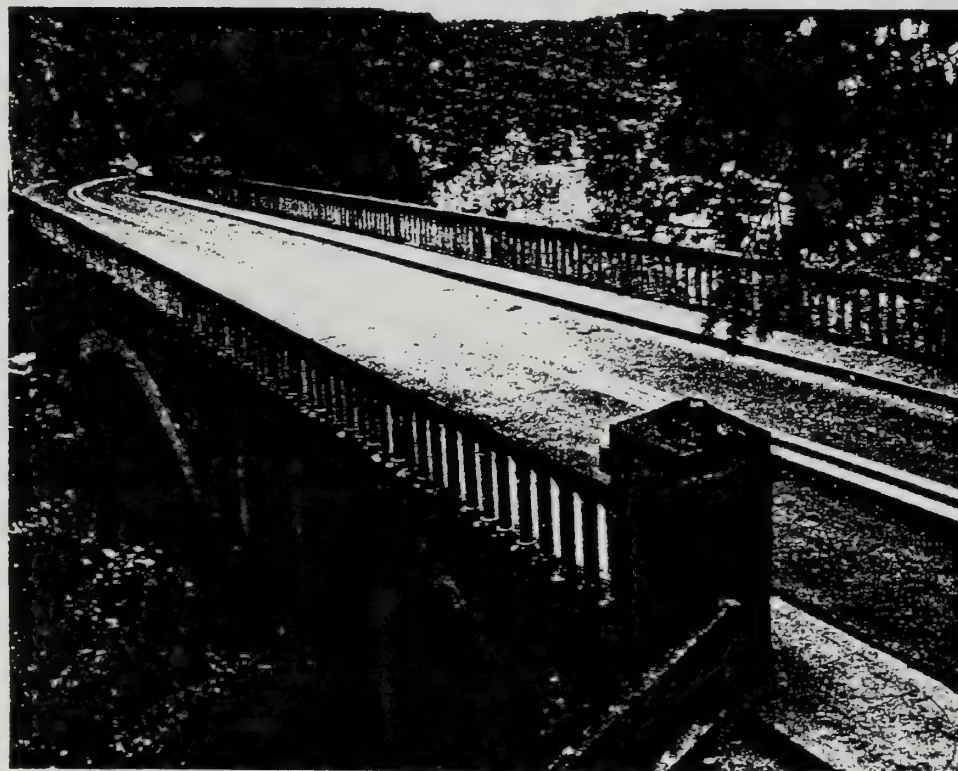
Fig. 15c. The new concrete spindles have been installed. This sensitive renovation reused the historic concrete cap railing and stone piers, as they were still in sound condition.

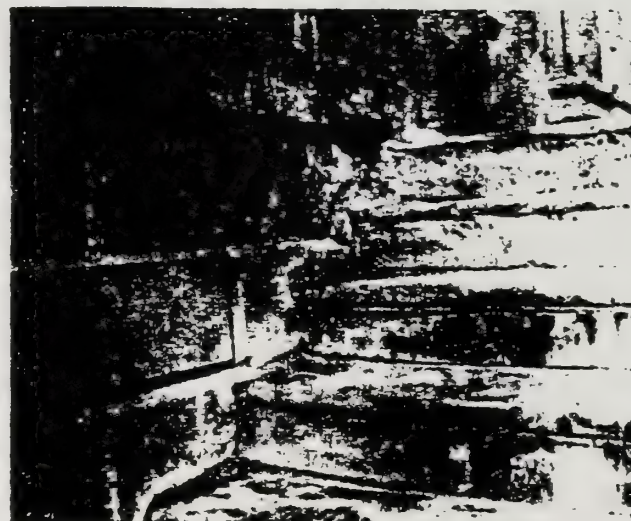
Commercial salt dumped on icy winter steps has a drastic, corrosive effect upon stone.

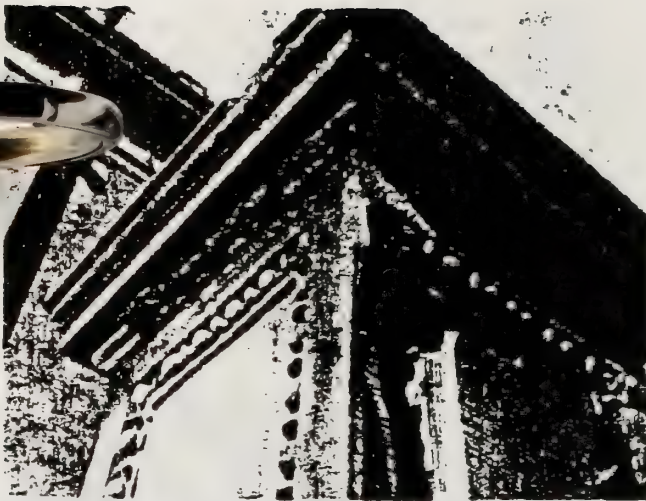
This sandstone gatepost has eroded because of crystallization and acidic action.

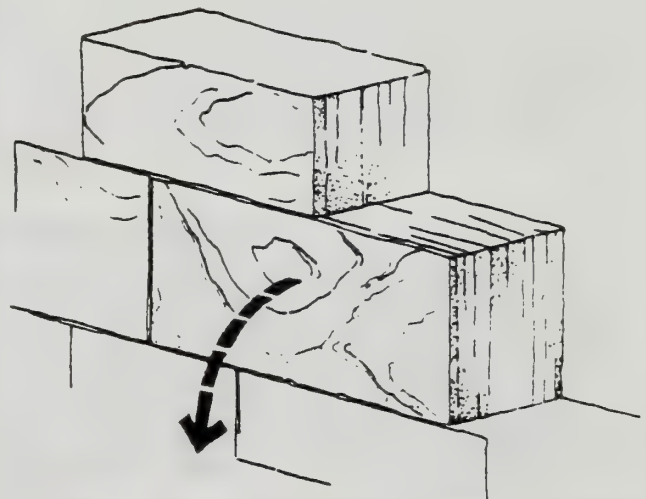
A face-bedded stone scales in layers because it was placed on end with its bedding planes parallel to the face of the wall. Face bedding accounts for the poor condition of many mid-19th century brownstone buildings. (Arrow indicates scaling.)

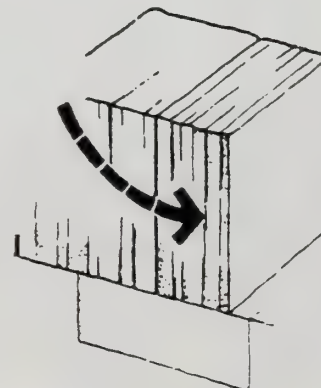
An edge-bedded stone has its bedding planes perpendicular to the face of the wall. Seams on the exposed surface (indicated with the arrow) will wash out in time.

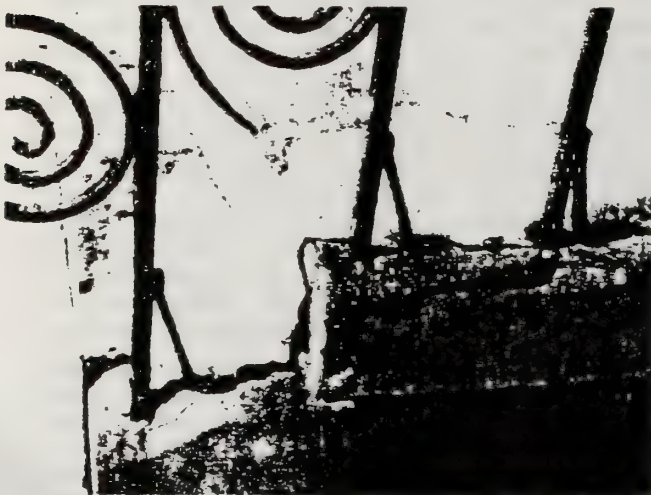
The embedded end of this iron railing has expanded as it rusted, cracking the corner of the sandstone step.

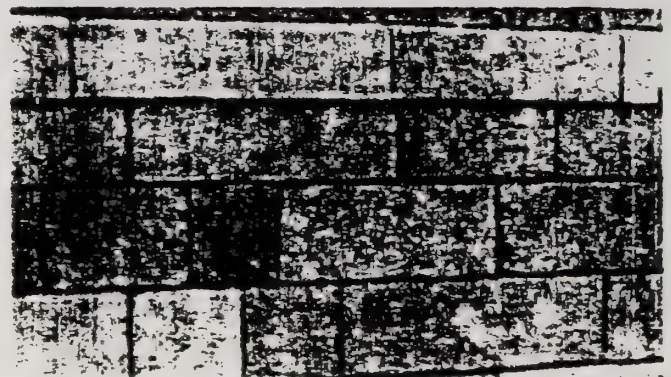
Sandblasting has left this stone water table badly pitted and scarred.

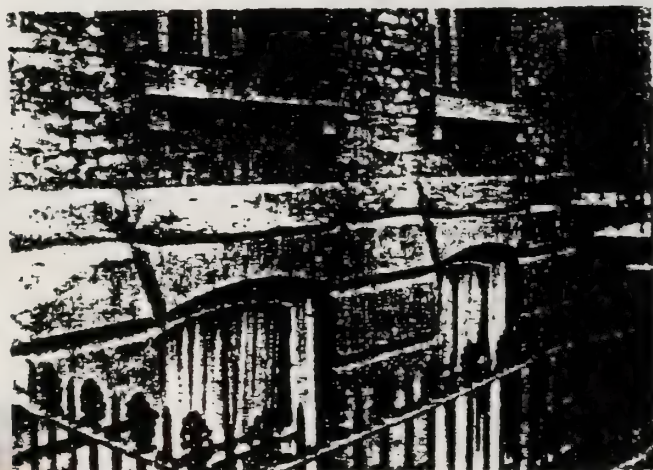
Decayed portions of this brownstone water table have been chiseled out, in preparation for plastic repair. The sills and basement, which had also deteriorated badly, have already been repaired.
